# ATTACK ON CAM RANH 25 AUGUST 1971

SPECIAL REPORT

15 DECEMBER 1971

Directorate of Operations Analysis
CHECO/CORONA HARVEST DIVISION

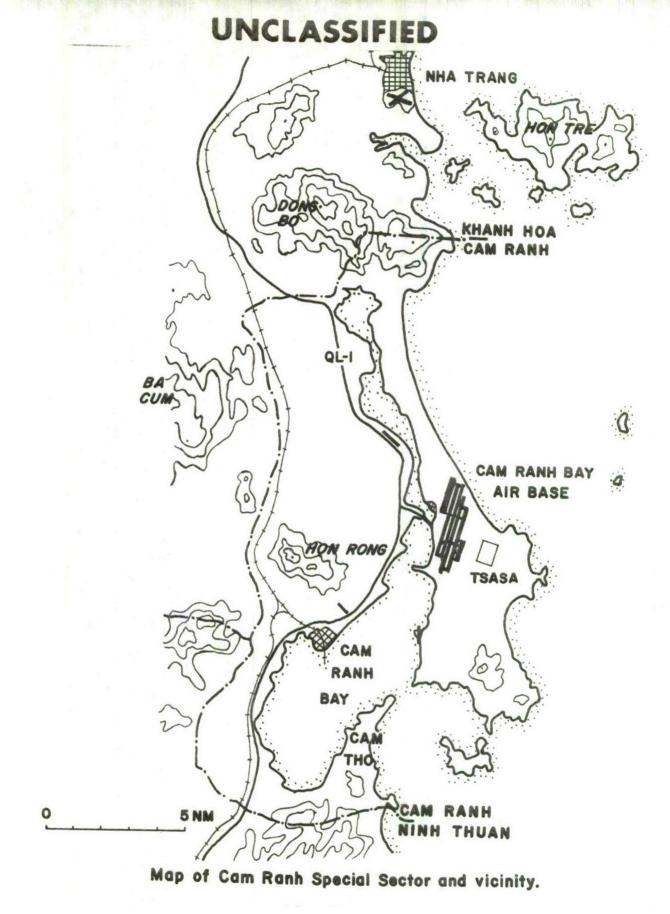
FIGURE 3

The area contiguous to Cam Ranh Bay falls within the geographical confines of the Cam Ranh Special Sector, one of six autonomous cities within the Republic of Vietnam (RVN). Since 1965, its population had quadrupled to over 100,000; the majority of the people resided on the coastal plain along the principal highway, QL-1. The coastline curves in a southwesterly direction and then extends sharply to the northeast, forming the inner shoreline of the Cam Tho Peninsula. Cam Ranh Bay is sheltered from the South China Sea by Cam Ranh Peninsula which stretches approximately 30 kilometers. The gateway to the bay lies between the Cam Tho and Cam Ranh Peninsulas. (See Figure 3)

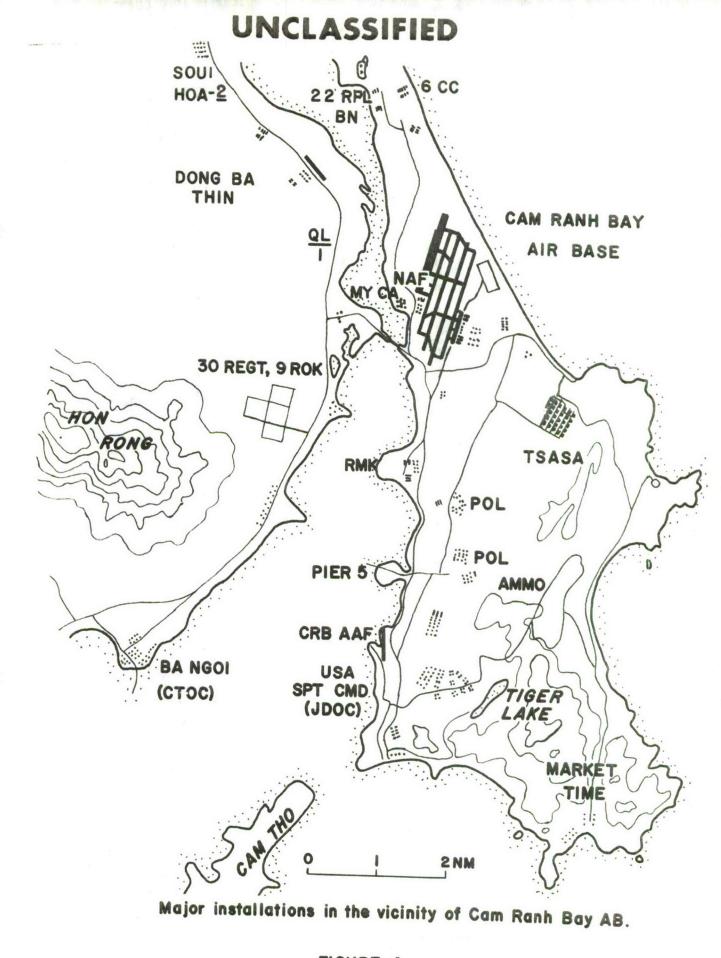
FIGURE 4

interspersed along the bay shore. Many Third Country Nationals (TCN) as well as Americans lived in military compounds. Major installations in addition to the Air Base were the U.S. Army Support Command (USASUPCOM), the U.S. and Vietnamese Coastal Surveillance Force ("Market Time"), the Vietnamese Naval Training Center, the 6th U.S. Army Convalescent Center and the 22nd Replacement Battalion (U.S. Army). The major link to the mainland was via My Ca Bridge, located south of the air base runway. (See Figure 4)

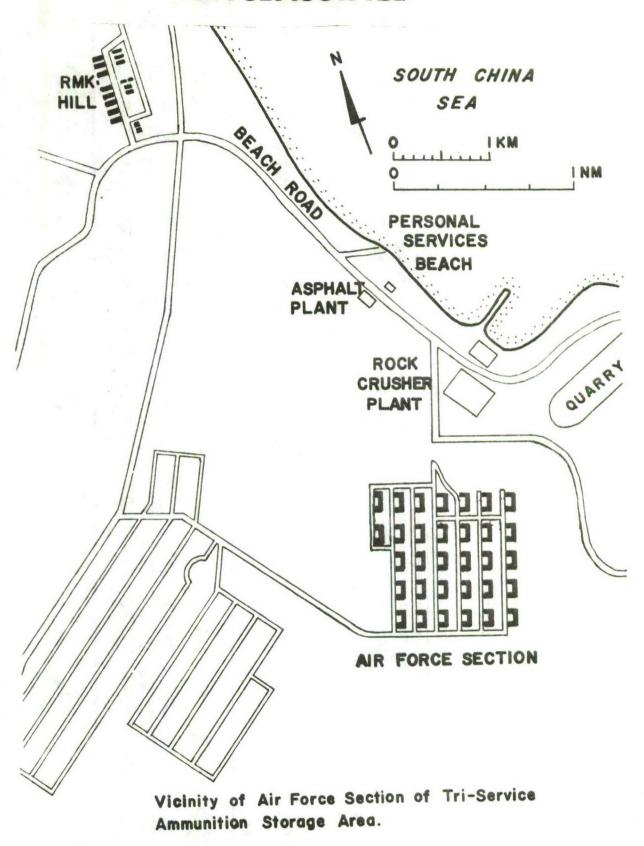
FIGURE 5

Cam Ranh Bay Air Base was an expansive complex that lay midway up the peninsula. In its southeastern sector, the Air Force portion of the Tri-Service Ammunition Storage Area was situated adjacent to territory under the control of the USASUPCOM. Two distinct sections used jointly by the U.S. Army and U.S. Air Force comprised the TSASA. The U.S. Navy stored small amounts of munitions within the Army sector. In 1969, a Memorandum of Understanding between the 12th Tactical Fighter Wing and the U.S. Army Support Command delineated the security and maintenance responsibilities for each sector. As used hereinafter, TSASA applies only to the Air Force portion. (See Figure 5)

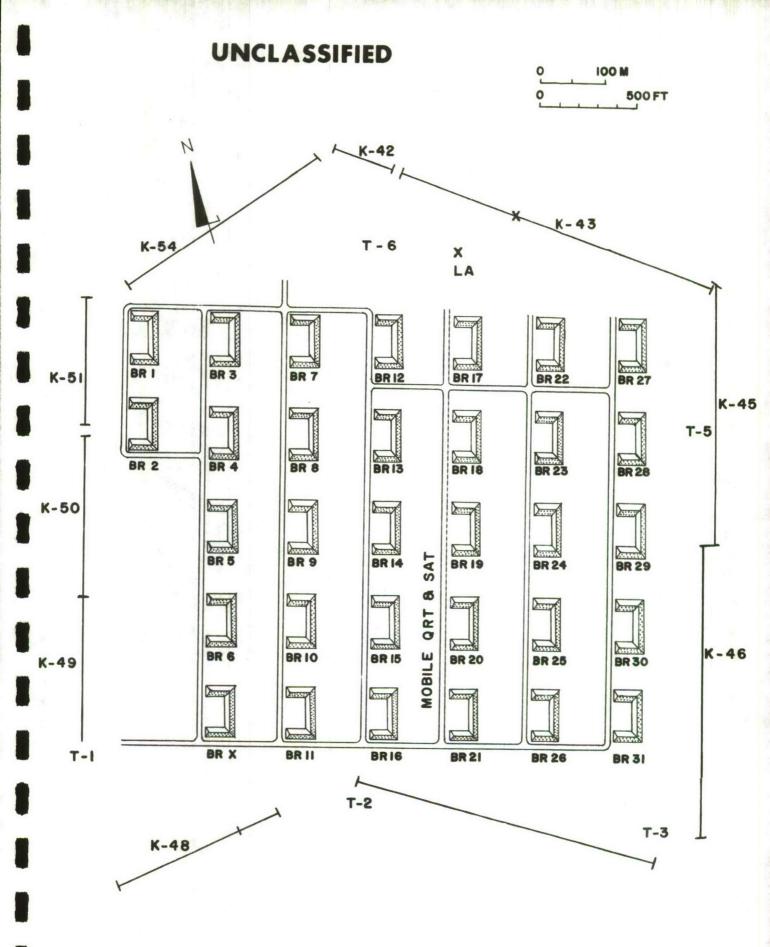
FIGURE 7. Disposition of security forces in Air Force Section of TSASA.

Eleven sentry dog teams (K-9) and five tower guards manned the perimeter; the dog teams provided the greatest deterrent to penetration into the area. A three-man Security Alert Team (SAT) and a six-man Quick Reaction Team (QRT) were mobile within the dump. The QRT, Quebec Cobra, moved within the interior and stopped at selected points and listened for suspicious movement, and the SAT continually patrolled the roads.

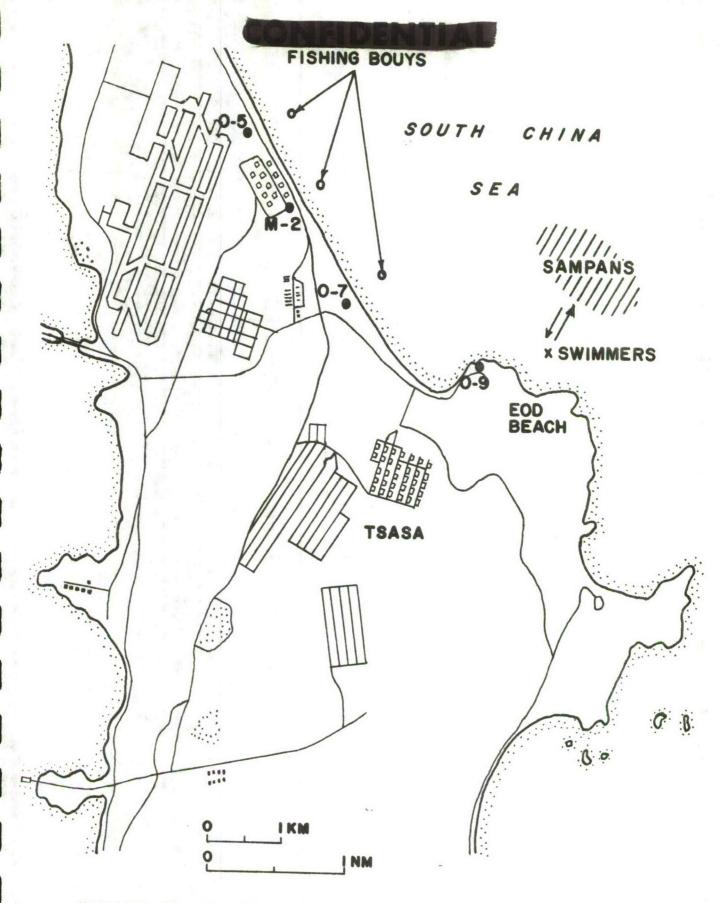
FIGURE 10. Seaside activity near Tri-Service Ammunition Storage Area.

While the swimmers and sampans were under observation for approximately five to ten minutes, CSC relayed requests to JDOC for helicopter and watercraft support. Helicopters from DBT and patrol boats were not available for immediate reaction. Twentieth Special Operations Squadron (SOS) scrambled two helicopters in response to the plea relayed through the Wing Command Post (WCP), but the aircraft arrived on the scene too late to assist effectively the efforts to apprehend the suspicious sampans. By the time the helicopters were airborne, the sampans had already intermingled with several other fishing boats in the waters due east of the TSASA. Ground observers directed the gunships over the sampans; the pilots informed CSC that one boat contained women and children and the other contained four Vietnamese male fishermen with  $\frac{65}{1}$  The JDOC log version read:

The sappers had the choice of concealment on the peninsula or immediate escape via the sea. The second alternative seemed most likely since the personnel on 0-9 observed two swimmers heading seaward from the EOD Beach area. The sampans which recovered the two swimmers may have retrieved others during the period when security personnel could not watch the sampans. The sampans departed with at least two of the sappers who executed a flawless attack.
